Modernization and Characterization of the Riga SLR Timing System

Evan Hoffman[1], Kalvis Salmins[2],
Jorge D. Pino[2], Aivis Meijers[2]

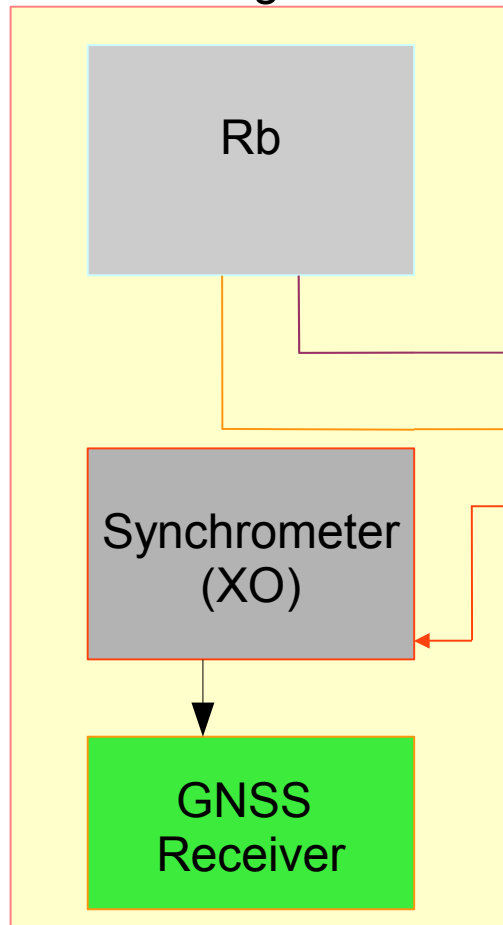
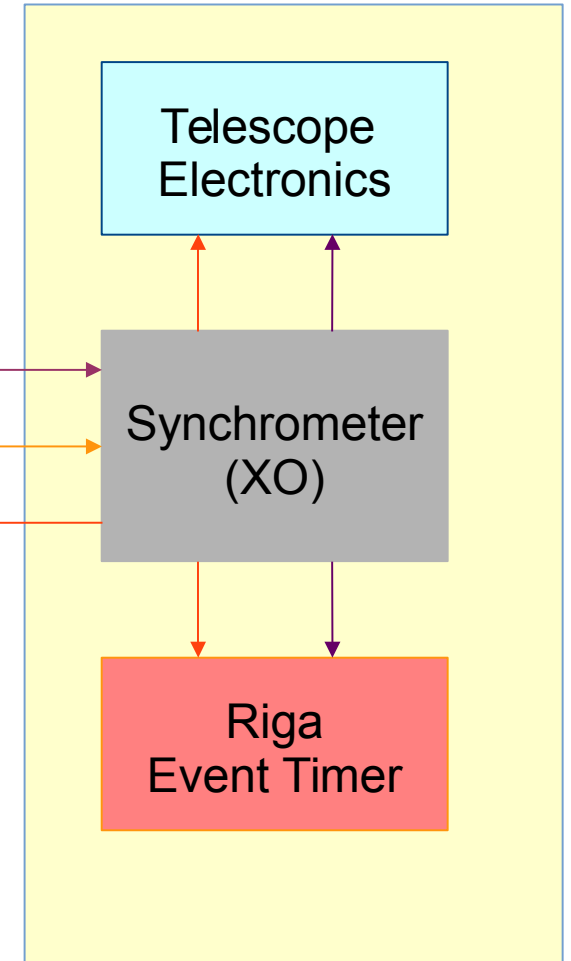
Old Setup

- Frequency standard was an unsteered rubidium oscillator
- Timing system and laser system are in separate buildings
- Time (1 PPS and Frequency) is delivered via a coaxial cable run between buildings
- Rubidium generated 1 PPS was sent to the laser system
- A synchrometer was located in each of the buildings, used to distribute time and generate signals
- 1 PPS from laser system synchrometer was synchronized to UTC by sending it back to timing building for comparison with GPS receiver

Temperature Controlled
Timing Room

5 MHz

1 PPS

Coaxial

Telescope Building

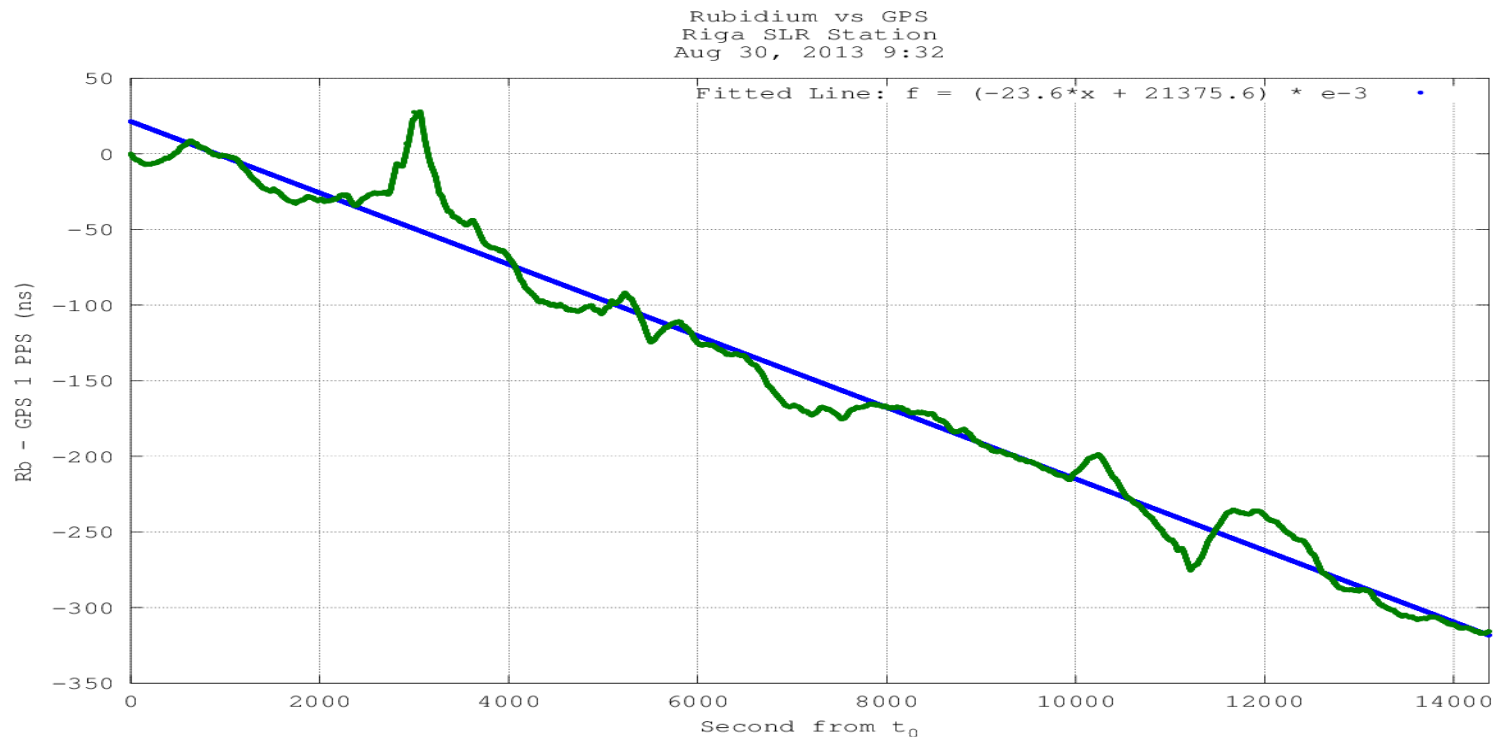
- Rb Standard > 25 years old, significant drift
- Synchronization equipment equally as old, reliability untested
- Sync to UTC manually monitored
- Poor or non-existent documentation

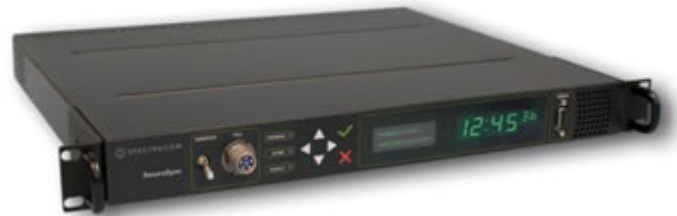
- Based on Spectracom SecureSync timing unit with GNSS steered rubidium oscillator
- Replacement for frequency standard and Synchronization system

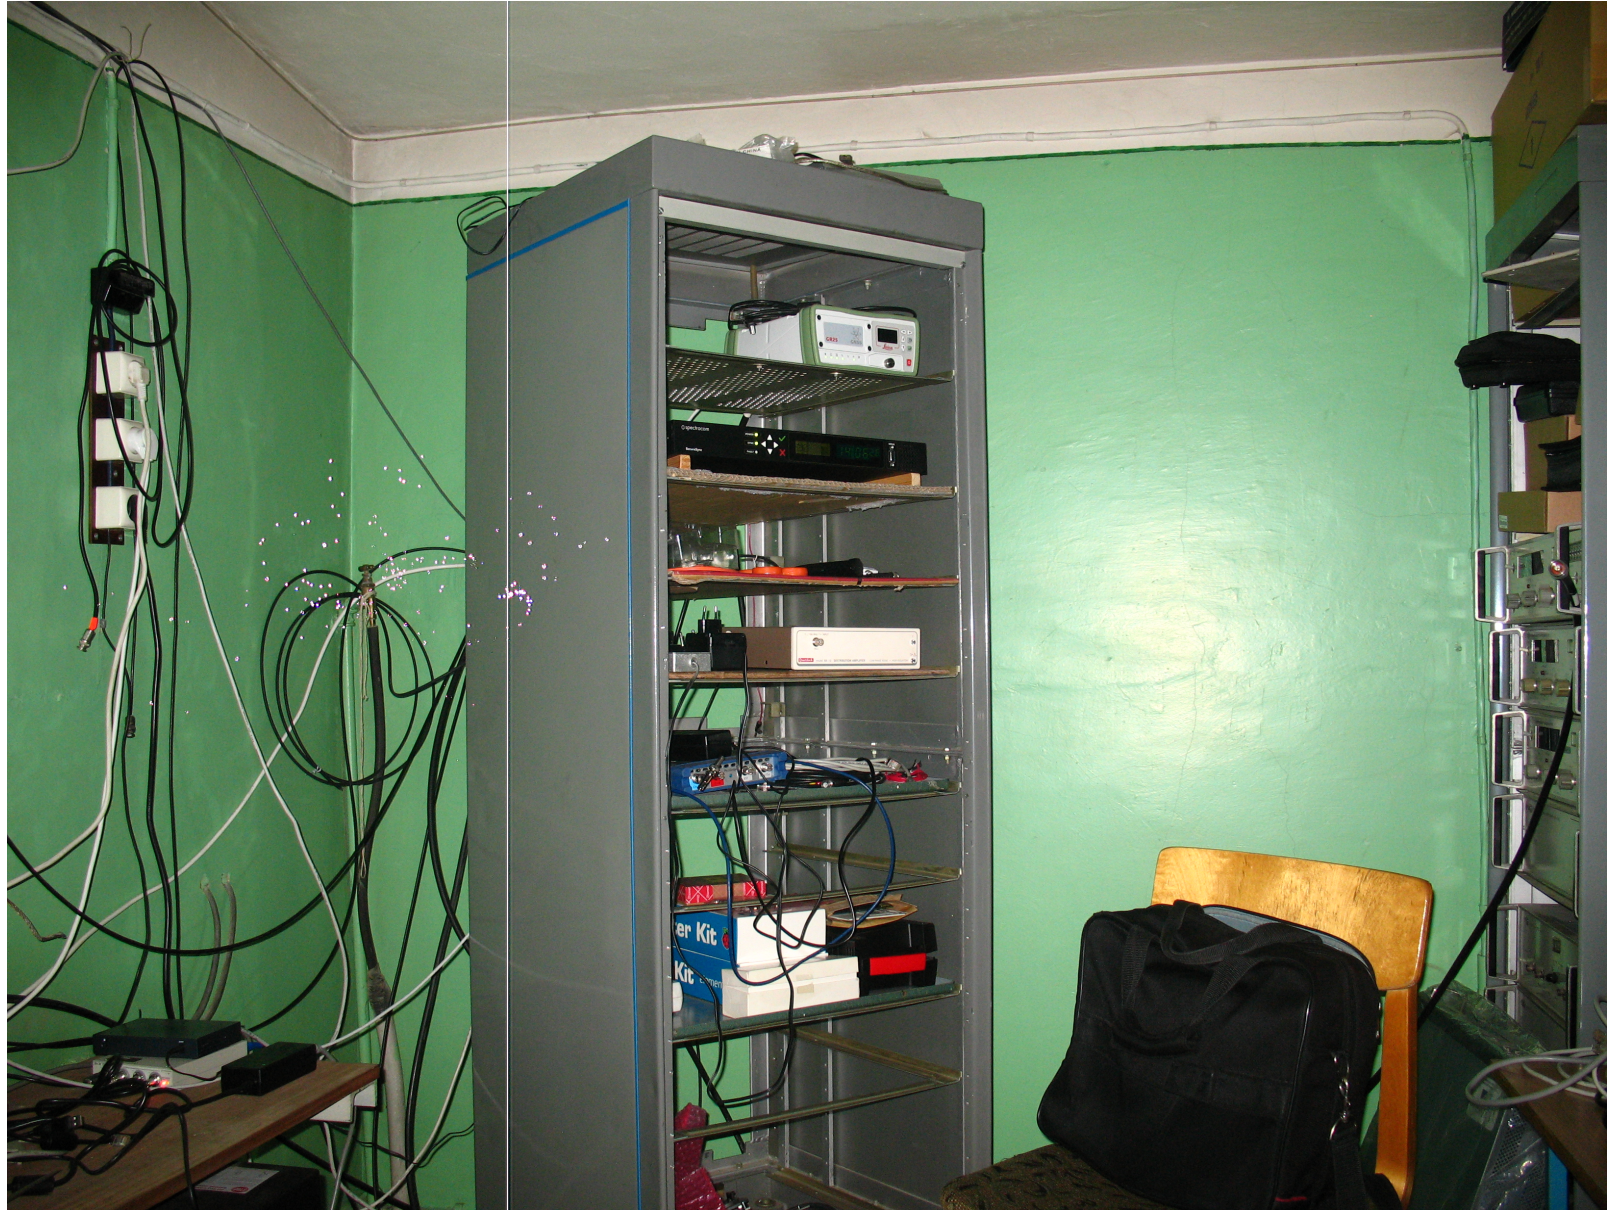
New Timing System

Planned Setup

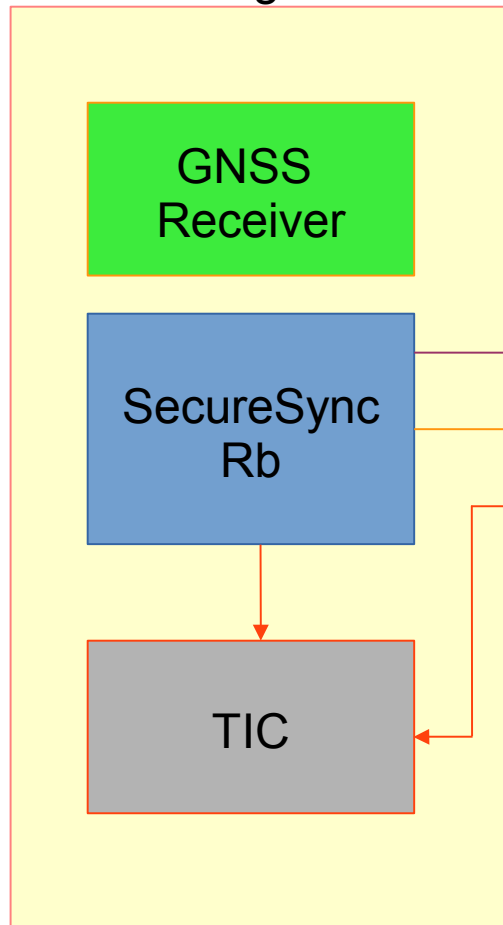
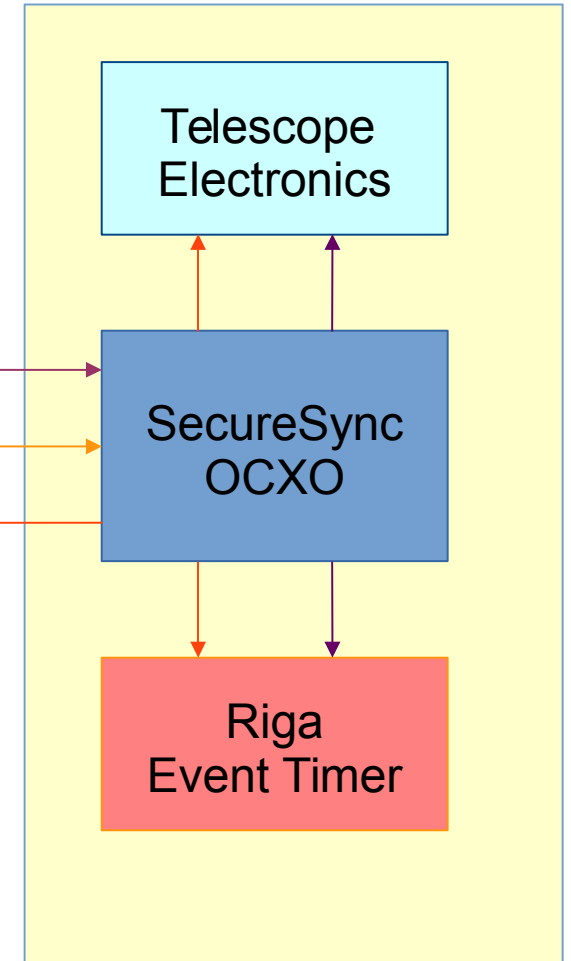
Temperature Controlled
Timing Room

Telescope Building

10 MHz
IRIG B
1 PPS

Coaxial
(plans to
replace with
fiber in
future)
