Modernization and Characterization of the Riga SLR Timing System

Evan Hoffman (GFZ Potsdam)

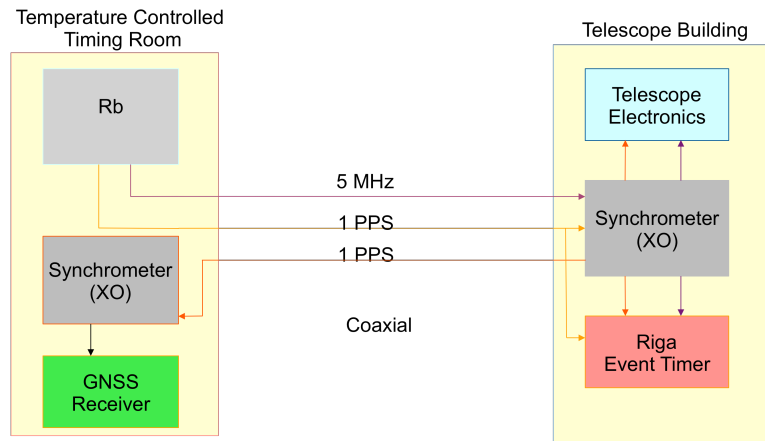
Figure 1: Simplified Old Timing System Setup

Figure 1 shows the setup of the old timing system. Most of the major timing equipment is located in a separate building, as the telescope building is not climate controlled. A 5 MHz sine wave and 1 PPS is generated by an unsteered rubidium standard CH73 secondary time standard and delivered to a synchronometer CH37 (tertiary time standard) located in the telescope building. This synchronometer then provides timing signals to the telescope control electronics, the event timer gets 1PPS and 5Mhz straight from the rubidium standard. A 1 PPS signal is sent from this synchronometer to an additional synchronometer located in the timing room. The rubidium is compared to a GNSS receiver to keep the 1 PPS relatively close to UTC, knowing the cable signal delays in the coaxial cable connecting the two synchronometers. The rubidium 1 PPS was adjusted in order to match the GPS 1PPS. The redundancy was built into the system to protect against equipment failure and power outages, as a second slip would otherwise not be noticed until tracking began. Additionally, BCD encoded time was transmitted to the telescope and displayed on a separate clock to assist in setting the proper time on the synchronometer at the telescope in case of a power outage.

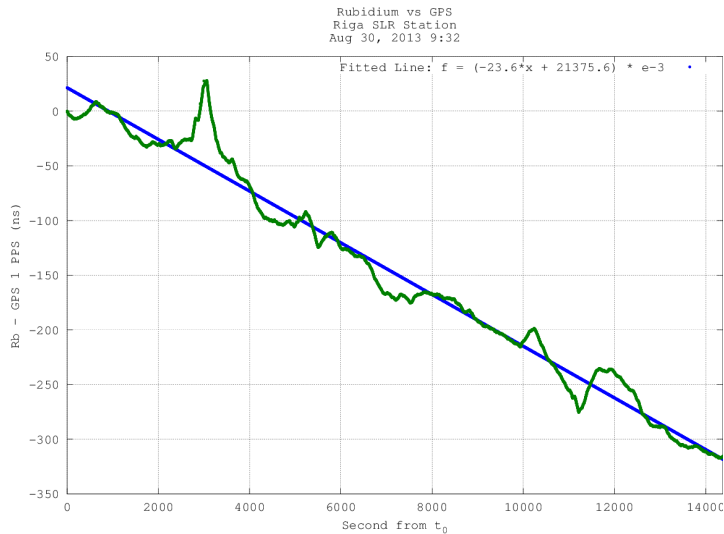
Figure 2: Long Term Drift Shown by old Rb

Figure 2 shows the drift of the rubidium over the course of several hours, as compared to a standard GPS receiver. A line of best fit has been plotted showing a large drift greater than $2 \mu\text{s}$ per day, which would require the operator to synchronize the 1 PPS multiple times during the day. Longer passes would cause even bigger problems. The advanced age of the device (over 20 years) also reduced confidence in its medium and short term stability.

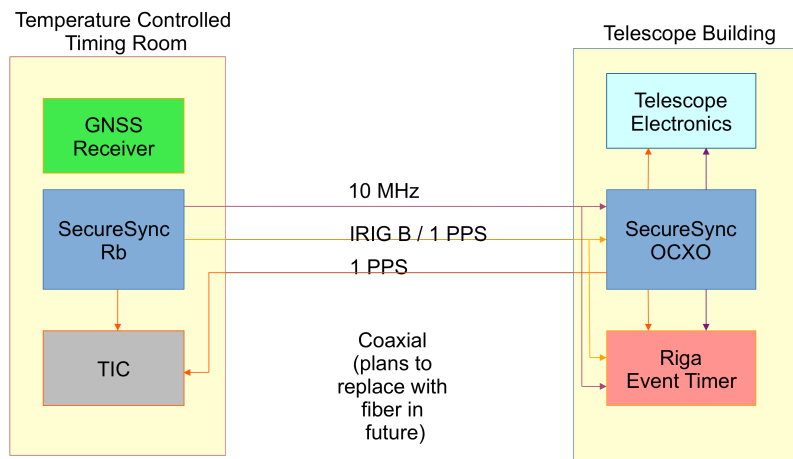
Figure 3: Planned Timing System

Figure 3 shows the planned setup for the new timing system. The base of the time keeping and signal generation is provided by the Spectracom Securesync synchronization system, replacing the old

rubidium and the synchometers. A Securesync unit equipped with an internal rubidium oscillator is our primary frequency source. The rubidium oscillator in this unit is steered by GNSS. A second Securesync with a oven controlled crystal oscillator is placed in the telescope room with synchronization to the primary source provided by an IRIG-B/1 PPS setup. This has an advantage of passing epoch information as well. Coaxial lines will be replaced with optical fibers to deliver time signals. This has the advantage of lower signal jitter as well as greatly reduced temperature dependence for the signal delay.

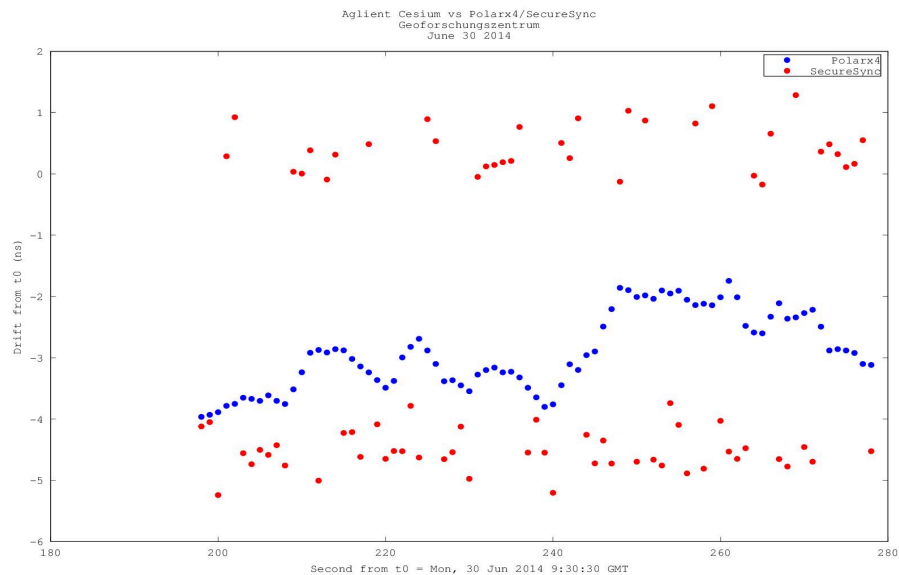
Figure 4: 3 Way Test

Figure 4 shows a short section of the test. The red data points represent the SecureSync, while the blue data points are obtained from the other GPS receiver. Both represent drift relative to an arbitrary starting time versus the cesium. There was an oscillation between small groups of 1 PPSs generated by the SecureSync roughly 5 ns in magnitude. It is not present in the GPS receiver, showing the problem resides with the SecureSync. Further tests conducted on the 10 MHz revealed no jumps in phase in relation to the 10 MHz of the cesium that would suggest a problem with the rubidium oscillator itself, pointing to the 1 PPS generation being an issue. These findings were reported to the manufacturer, who subsequently discovered a software bug causing the issue. A software update is expected in early 2015.

Tests are ongoing to test and validate the system in terms of function and performance. The 1 PPS of the Securesync was compared to a 1 PPS generated by a cesium clock with a high performance tube over the course of several days. A third GPS disciplined oscillator was used in parallel to verify the measurement.

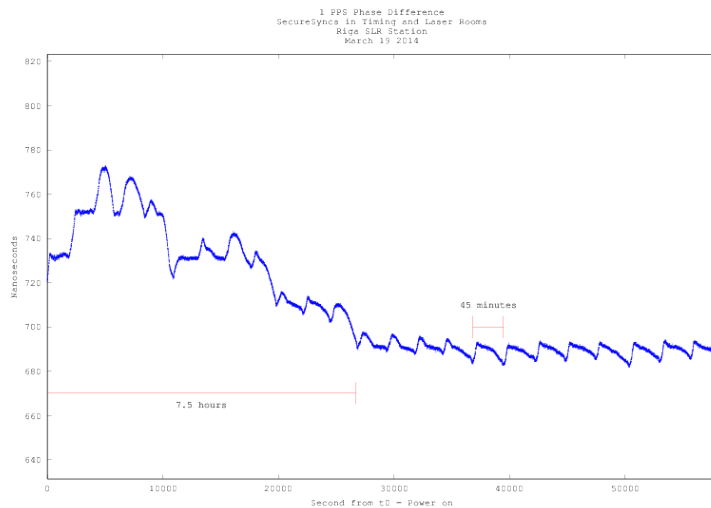
Figure 6: IRIG-B Test

Figure 6 shows tests performed on the IRIG-B. Phase error measurements were performed on the remote and local SecureSync units in the timing room and the telescope building. The unit showed about a 7.5 hour settling time after power-on of both units. A saw-tooth pattern was also visible in the error with a period of about 45 minutes, and an amplitude of about 10 ns. It is unclear whether this will improve after the software update, however further tests are planned.

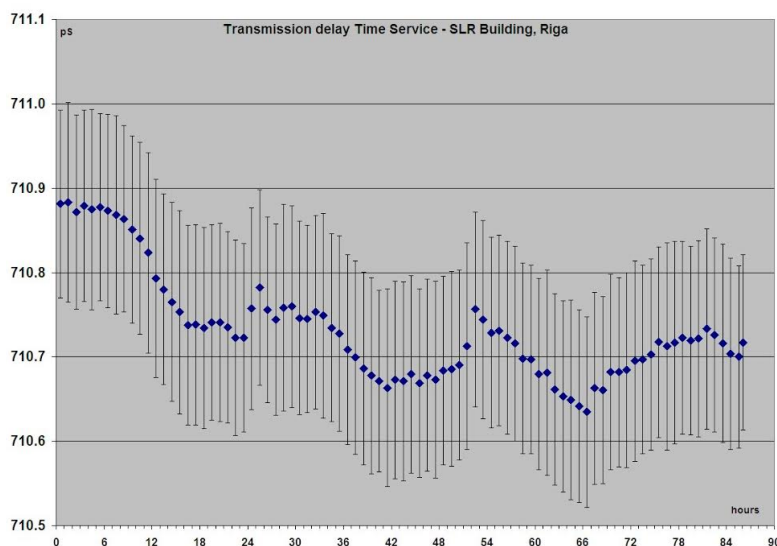
Figure 7 Signal Delay Measurements, Winter

Figure 7 shows a signal delay test that was performed on the coaxial cables running from the timing building. A pulse was applied to one end of the cable, with the other end disconnected. The open circuit round-trip reflection time (y-axis) of the pulse was measured at a sample rate of 0.20 Hz over a period of several days. Data were noisy due to limitations in measuring equipment, but a slight diurnal trend was shown, with a noticeable 12 hour lag when correlated with outside temperature. The trend is weak enough (<100 ps one way) that it should not have a significant effect on the overall stability on a day to day basis. More tests are being analyzed with data taken during the summer to establish seasonal effects. Installation and testing of fiber is also planned, which should make the effect even smaller.
